Public Officials & Public Informational Meeting

Bridge & Culvert Replacement NHDOT Project No. 42558

Bridge No. 140/097 – US Route 2 over Priscilla Brook

Culvert – US Route 2 over Unnamed Stream

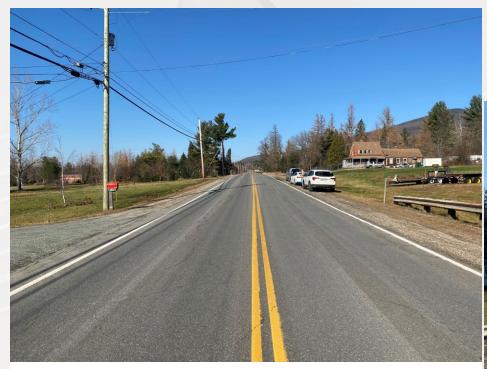
Looking West Along US Route 2

- Local driveway southwest corner of bridge
- Aerial utilities on south side of US Route 2

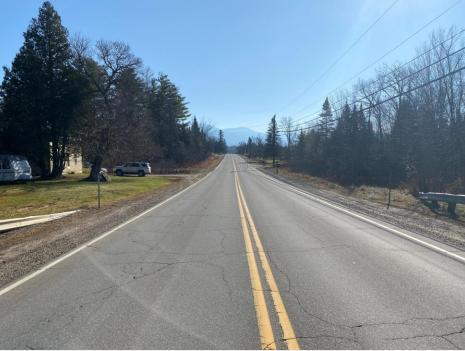
Looking East Along US Route 2

- Local driveway northeast end of approach
- Aerial utilities on south side of US Route 2

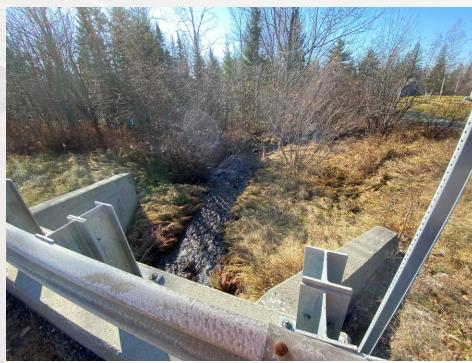
Looking Downstream (South)

- Outlet approximately 2' lower than inlet
- Driveway runs parallel to the stream

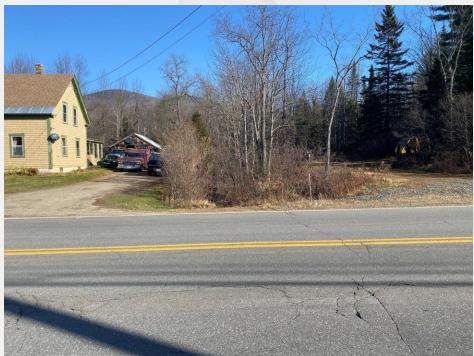
Looking Upstream (North)

• Inlet located between two driveways

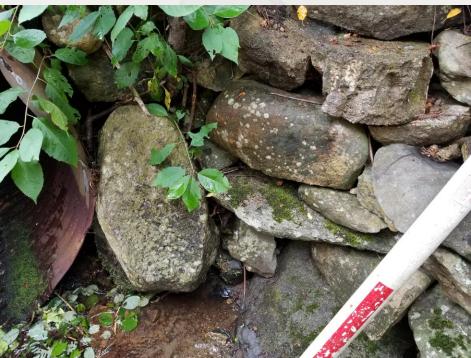
Stacked Stone Wall (Inlet)

- Originally constructed in 1930
- 4' x 4' concrete box culvert, 36'-0" in length
- Repairs made to box culvert roof (year unknown)
- 48" CMP extensions added to both ends
- Stacked stone retaining wall on upstream side
- Inlet located between two driveways
- 2,800 vehicles per day, 7% trucks
- Sink holes beginning to develop in roadway due to deteriorating culvert structure
